Appendix E2 – Restoration Plans and TMDLs (Restoration Plans)

Watershed Restoration Project Monitoring - Woodbridge

Woodbridge Year 1 Post-construction Monitoring

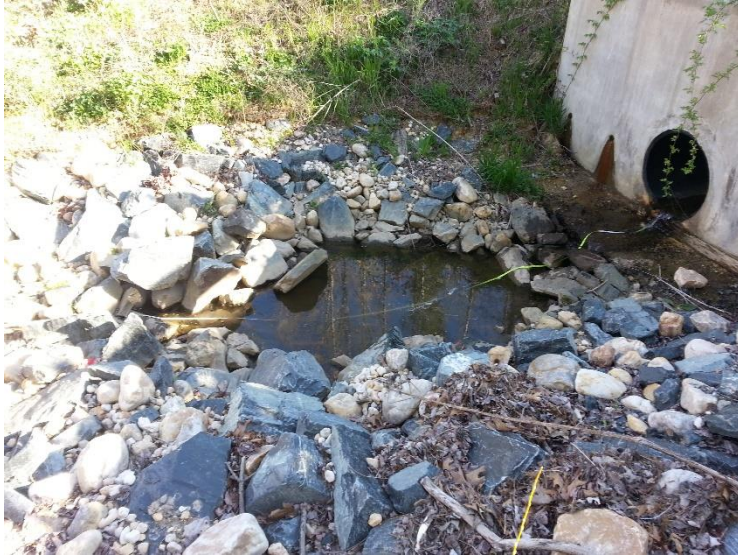
Station 0+10 facing left bank; possibly dislodged stones from pool

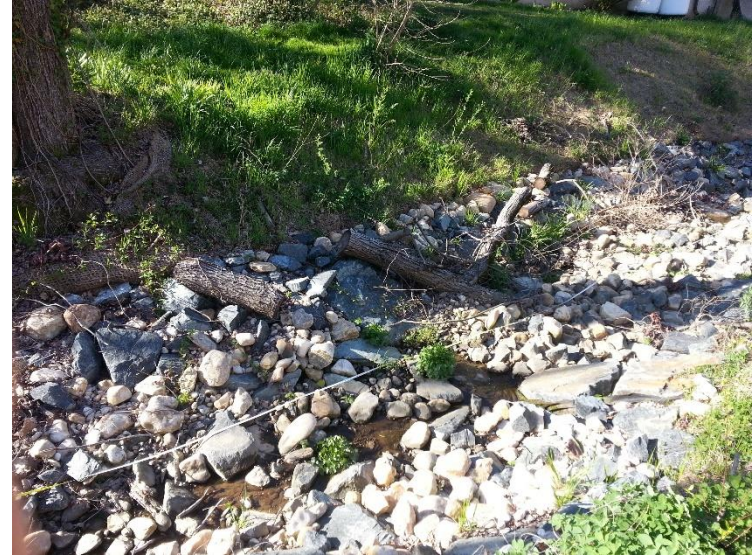
Station 0+80 facing left bank; cut tree in channel

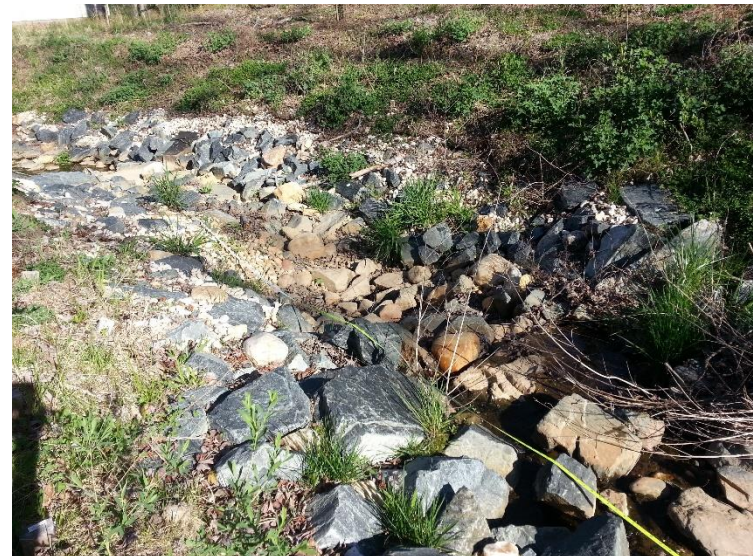
Station 2+25 facing right bank; pool and downstream riffle are dry

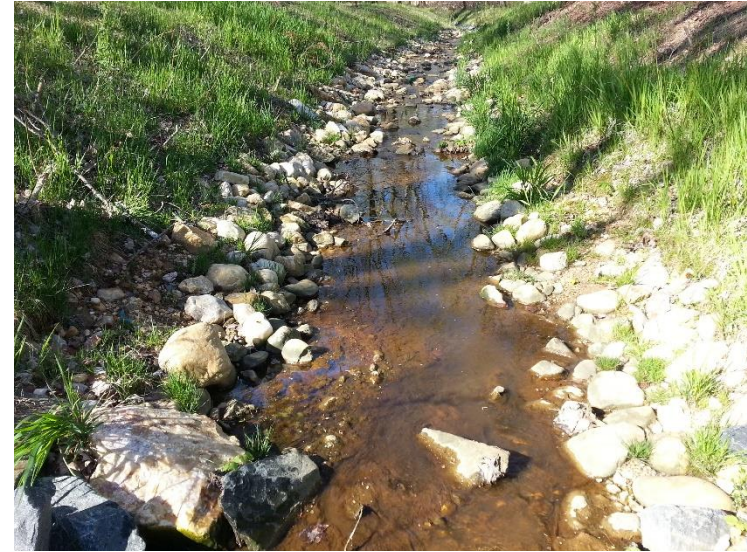
Station 3+50 facing downstream; minor left bank scour just downstream of riffle grade control

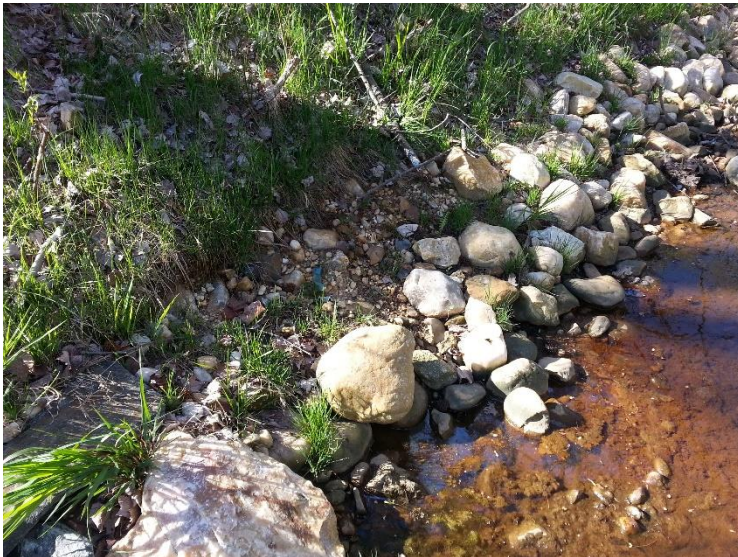
Station 3+50 facing left bank; minor bank scour just downstream of riffle grade control

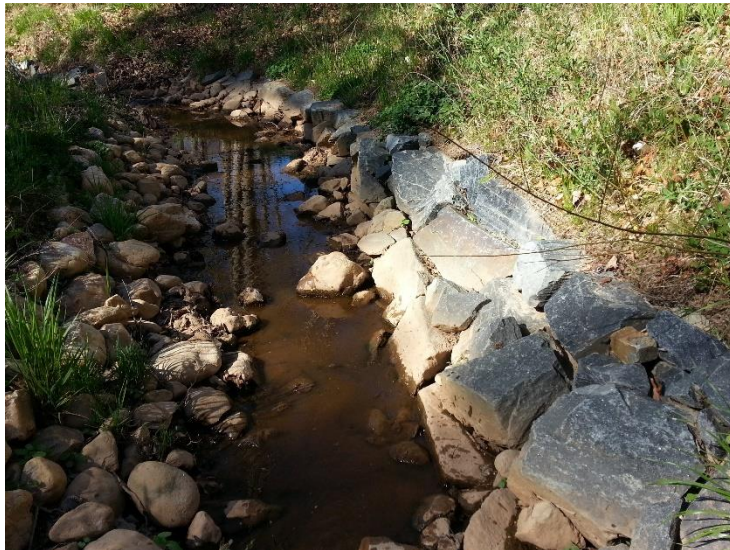
Station 7+90 facing downstream; stone toe protection more "stacked" than laid back, but stable
